BEARING FAILURE ANALYSIS

**Example Type B Report**

**Cylindrical Roller Electric Motor Bearing Failure**

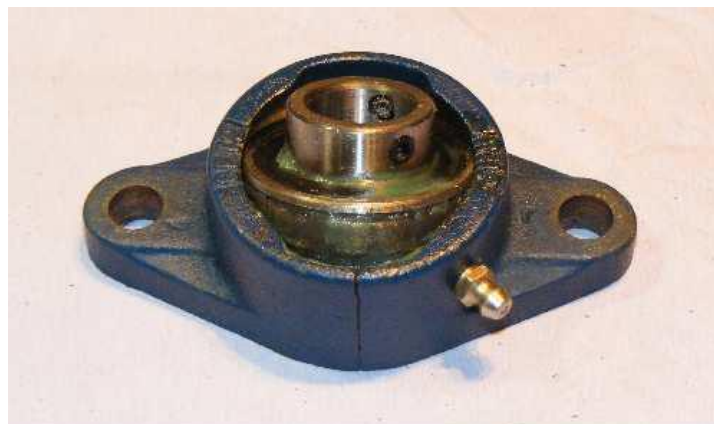
Fig 1

A single rhombic ball bearing unit (BBU) plus casting and bearing was supplied to us for inspection and report. We have no information on intended or fitted application. On removal of the outer packaging, the casting and BBU were found. A single hair line crack was seen running through the casting at a point approximately 90 degrees from the centre-line of the bolt holes, (See Fig 1).

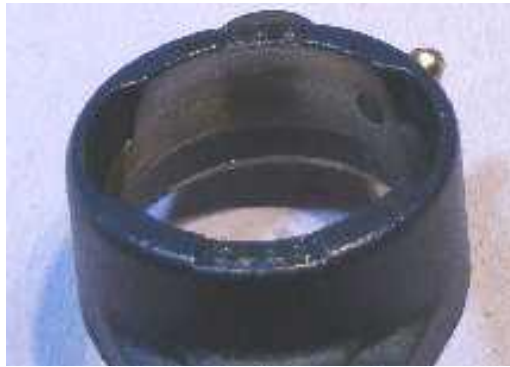
Fig 2

The machined self-aligning surface was then inspected. Points along the centre-line of bolt holes appeared normal and undamaged (Fig 2). However, evidence that a unit had been installed could again be seen.

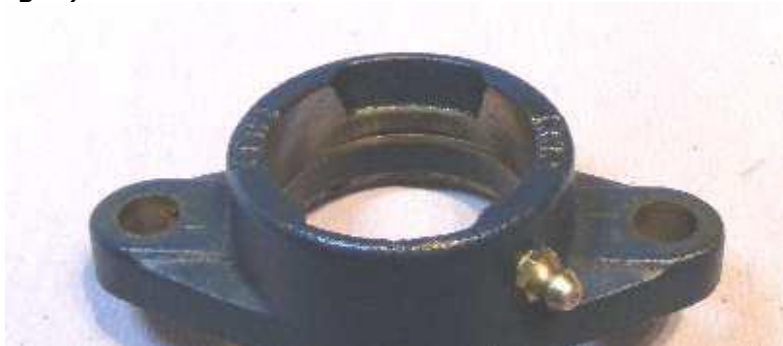
Fig 3

The casting was viewed at 90 degrees to the crack and a deep raised lip was noted (Fig 3).

The lip was inspected using a macro viewer and seen to correspond to the form and shape of the outer edge of the BBU outer ring. The marking clearly indicated that a grossly misaligned bearing had been present in the casting and that a large amount of thrust force, possibly from the tightening of the casting bolts, had been applied.

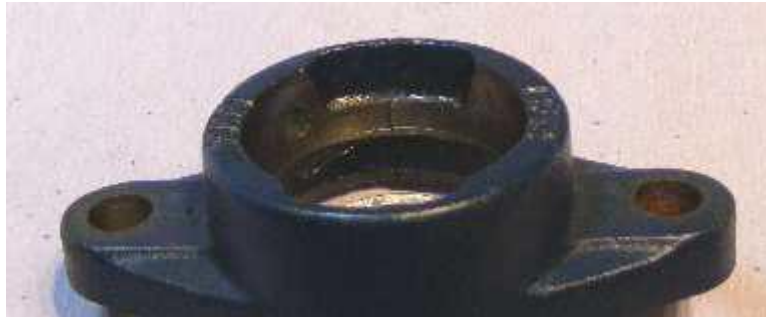
Fig 4

Once again a raised lip was seen, confirming misalignment and the application of an unnaturally heavy thrust force. At the thinnest point of the casting and correspondingly the deepest point of the lip, the crack was seen to run (Fig 4).

On this occasion a thrust load appears to have been applied to the casting as a result of the outer angle of the ball bearing outer ring being pressed into the casting under a condition of misalignment.

If the casting locating bolts are then fully tightened (with no attempt made to align the bearing within the casting during the tightening process) it is highly likely that the corner of the misaligned outer bearing ring will induce a stress raiser that will transmit heavy forces into the casting. This will almost inevitably result in cracking of the type seen on this occasion.
