BEARING FAILURE ANALYSIS

Example Type B Report

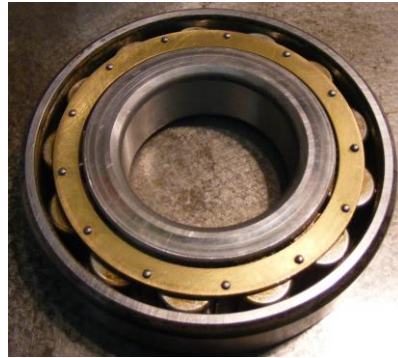
A single cylindrical roller bearing was supplied to us for inspection and report. See Fig 1.

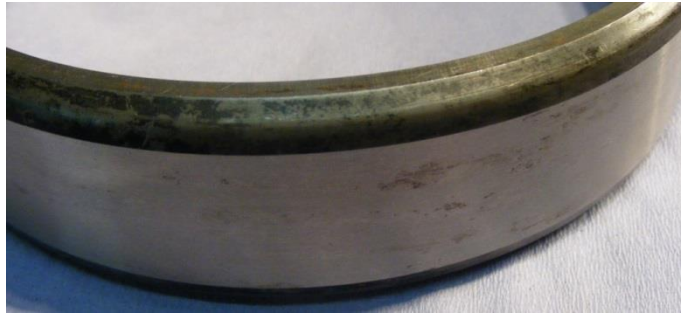
The outer ring was visually inspected, see Fig 3. There were clear fitting marks all around the outer surface. These marks were not excessive, suggesting that the bearing had not been installed for a long length of time. There was no evidence of out of square alignment or heavy handling marks.

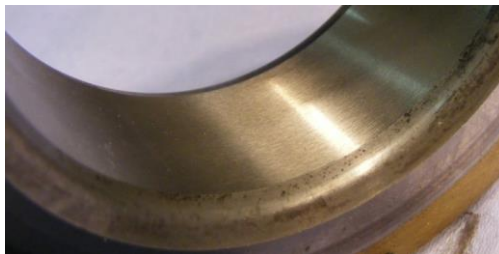
The inner ring bore was inspected and seen to have no abnormal fitting marks. See Fig 3. This lack of marking or fretting once again suggested that the bearing had only been in service for a short time.

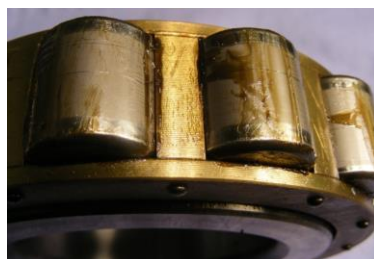
The inner ring prior to the cage being removed is shown in Fig 4.

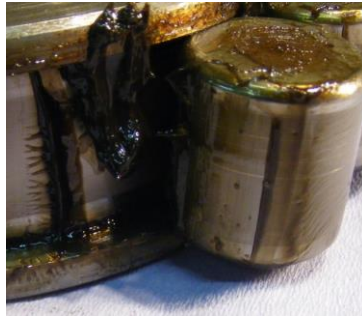
With the cage removed, ample grease was again found along with a similar frost like band around the centre of the inner raceway. See Fig 5.

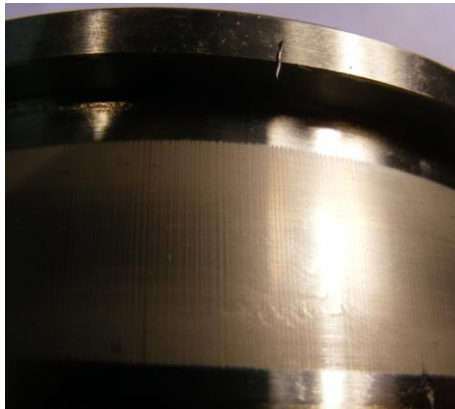
Following cleaning of the load bearing surfaces, fluting lines running across the load bearing surface were seen. When touched, these fluting lines felt rough and uneven and an obvious cause of bearing vibration whilst in service.

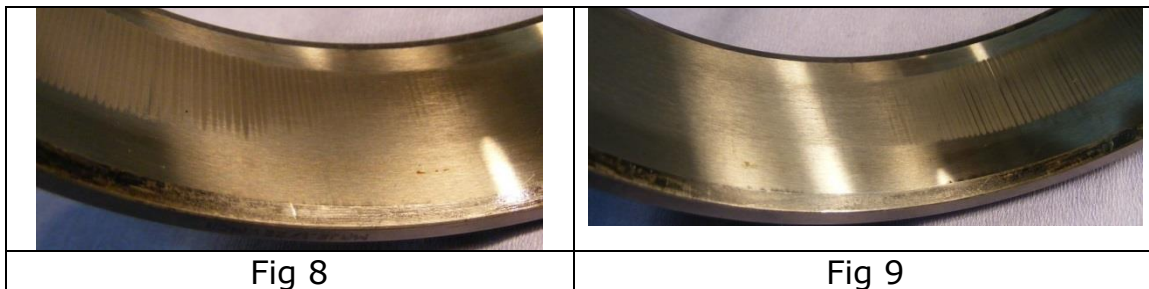
Fig 10 shows the central portion of the marking in the outer raceway, with approximately 60% of the raceway being fluted and the remainder being undamaged, see Fig 11.

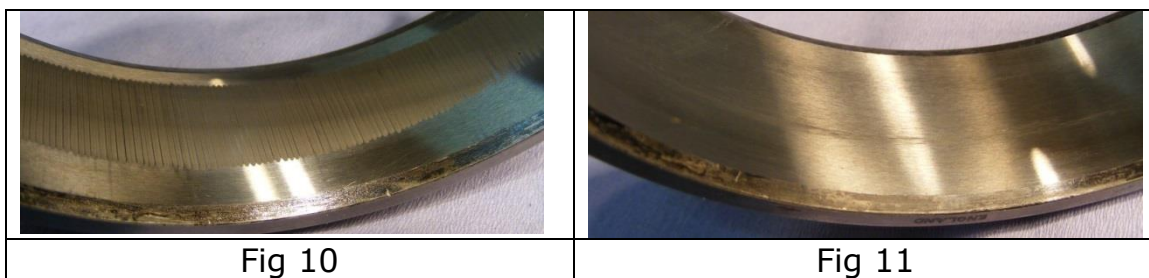
2.3 Rolling Elements

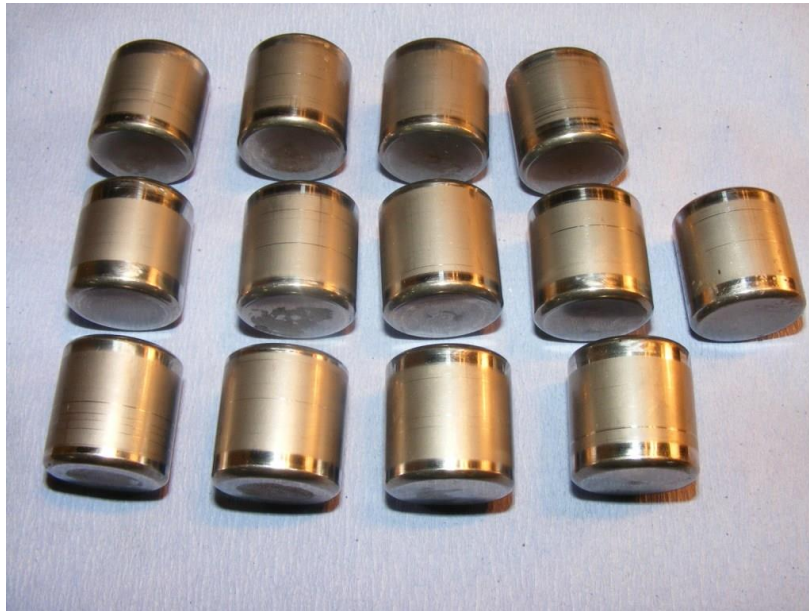
The thirteen cylindrical rollers were all seen to be dull and matted in the central load bearing portion, see Fig 12, rather than the shiny polished finish found at the roller ends.
