BEARING FAILURE ANALYSIS

Stratford House,  
4 Plough Drive,  
Market Rasen,  
Lincolnshire LN8 3DW.

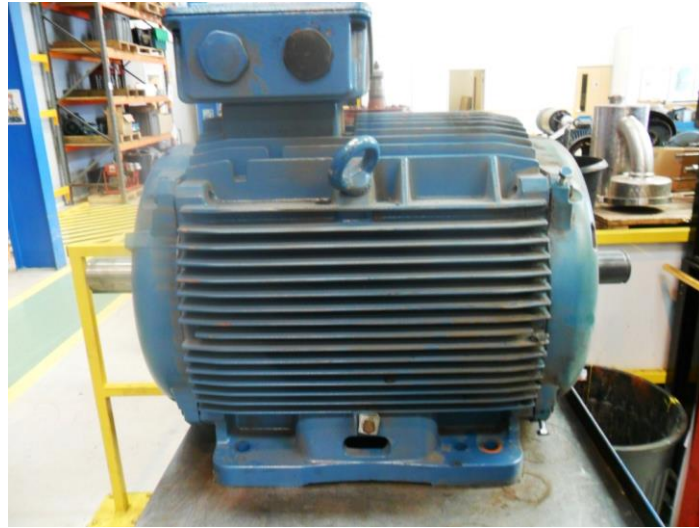
## 2. REVIEW OF IMAGES

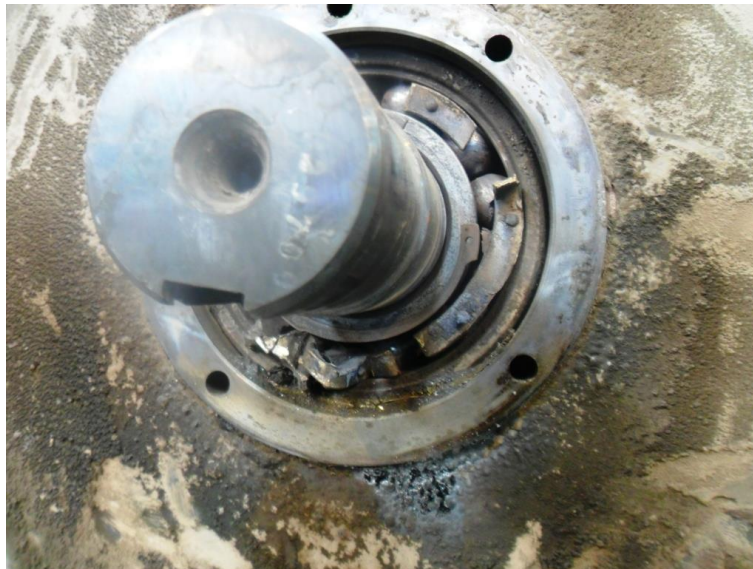
Image 1 appears to show a used electric motor. The condition and amounts of dirt, dust and similar appear to suggest the motor is from a relatively clean environment if the given service life of two years is correct. No evidence of impact damage can be seen in the picture.

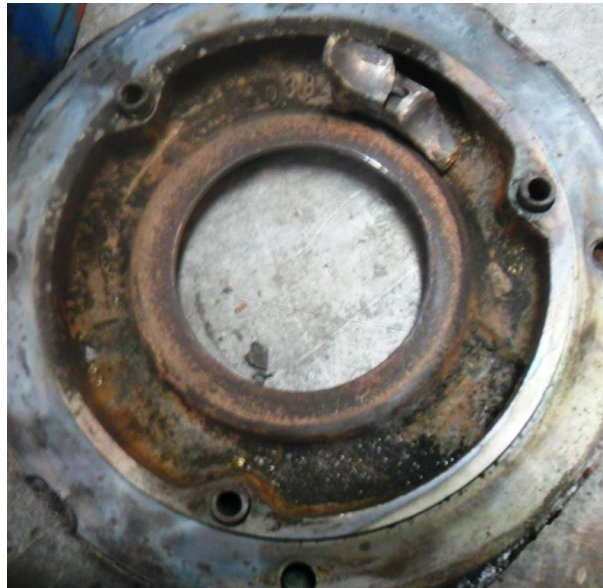
There are no signs of moist lubricant within the bearing voids or the housing area. Some evidence of moist grease can, however, be seen on the outer side of the machined surface
